# Home Inspection Report

## PROPERTY INSPECTION REPORT

**Concerning:** 123 Any Street Your Town, TX 12345  
(Address or Other Identification of Inspected Property)

**By:** Brad Brusenhan / TREC # 4176 10/7/00  
(Name and License Number of Inspector) (Date)

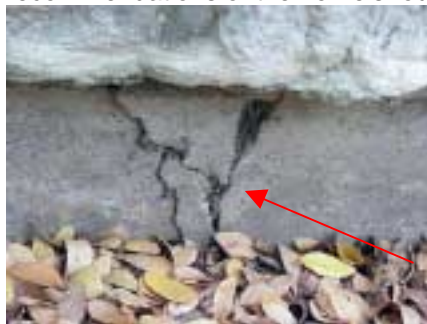
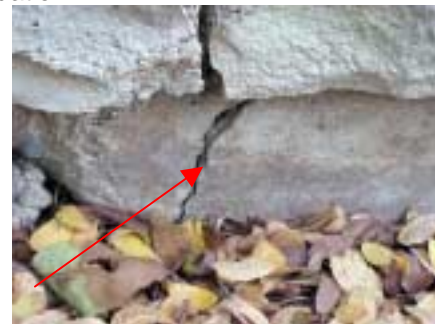
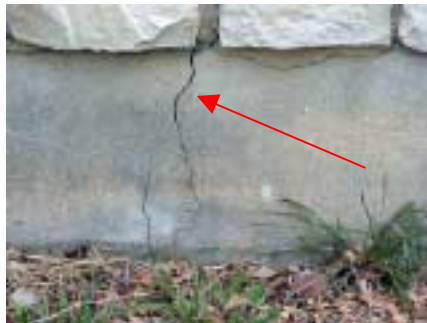
One vertical edge crack was observed at the front of the home on the right side of the front porch. Two vertical edge cracks were found at the rear of the home on the right side of the rear exterior door. The floors in the home are not level. Evidence of uneven settlement and/or heaving to the structure was observed. I recommend that you contact a structural engineer for further evaluation and repair recommendations of the home's foundation.

slab crack

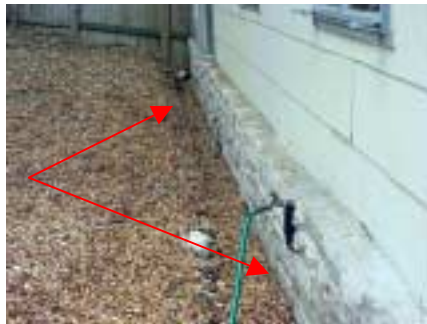
Drainage channels are located directly against the foundation at the rear and right sides of the home. It is not good practice to drain the water directly against the home prior to draining it off of the structure. The listing realtor has told me that the home has french drains. I have not verified the presence of these drains. In my opinion, their presence and function is not relevant considering the manner in which the soils near the home are currently graded. I recommend that you consult with a drainage specialist for further evaluation and repair recommendations of the homes drainage.

poor drainage at rear

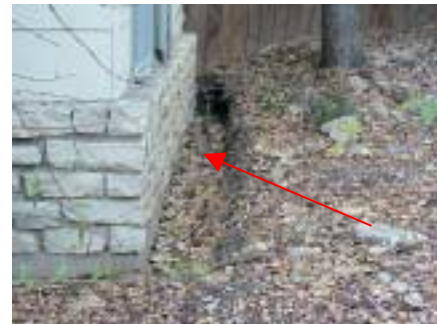
poor drainage at right

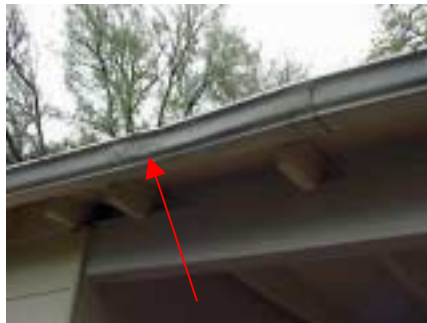
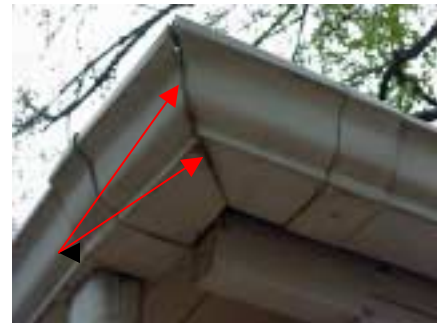
The gutters are clogged with leaves and need to be cleaned. Damage was found at the gutter on the left side of the carport. Evidence of leakage was observed at the seams. The seam at the front left corner of the carport is disconnected. The downspout extensions at the gutter is missing at the left side of the carport in two areas.

damaged gutter

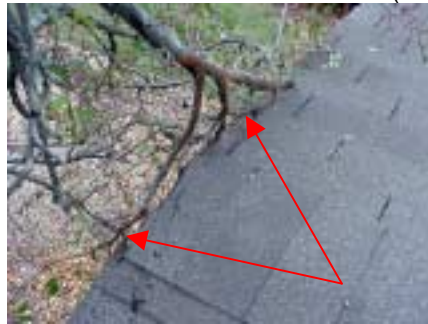
Damage was found at the shingles near the left edge of the roof. (tree limbs) Evidence of previous repairs was observed near the chimney and at the water heater flue.

trim limbs / damaged shingles

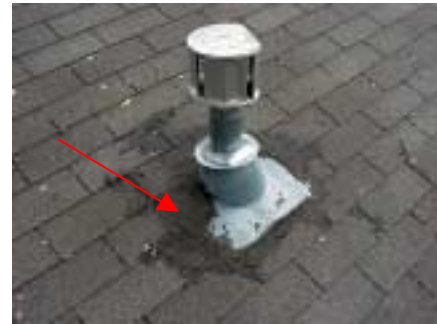
evidence of previous repairs

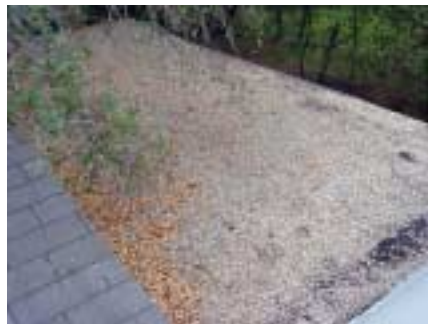
There are three types of roofs at this home. The roof above the carport is a low sloped, built up, tar and gravel roof. The roof above the front porch is a low-sloped rolled bitumen type roof. The roof above the home is a low-sloped composition shingled roof. Each of the roofs appears to be in average condition.

Based on wood rot at the roof structure below the built up roof at the carport, I recommend that you closely monitor the roof for evidence of leakage. Even if previous leaks have been repaired, they may resurface again as these types of roofs require ongoing maintenance and monitoring.

carport roof covering

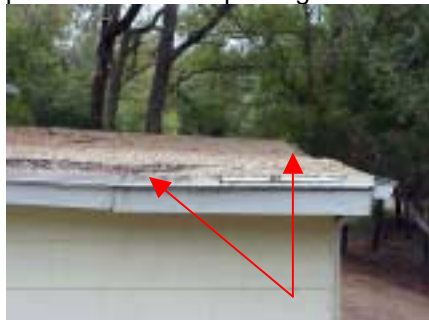
The roof structure above the carport is sagging and does not appear to be structurally sound. (repair or removal of the carport is recommended)  
 Due to the very shallow pitch of the roof, the attic space above the home was inspected from the attic hatch only. (limited) I found no visible evidence of problems while inspecting the attic space.

structural issues at carport roof

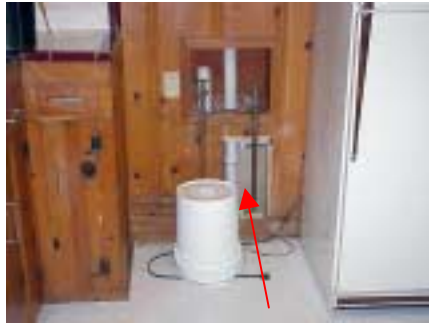
The wall is currently opened at the washing machine connections. (FYI)

wall opened below washer plumbing

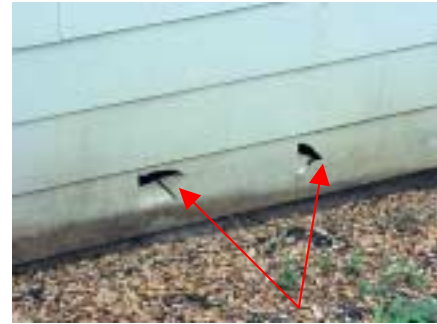
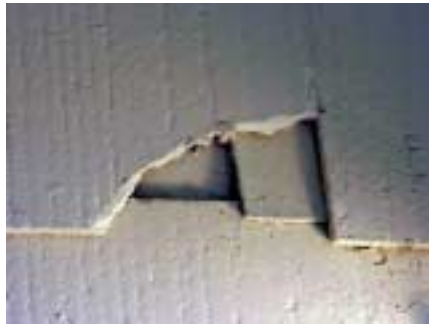
Several damaged tiles were observed at the exterior siding.

damage at exterior wall tiles

damage at exterior wall tile

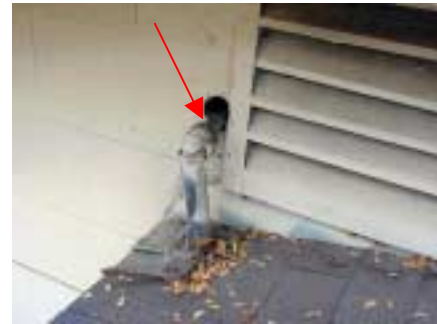
The hole in the wall at the exterior of the attic near the right side gable vent should be sealed.

seal hole at right side exterior wall

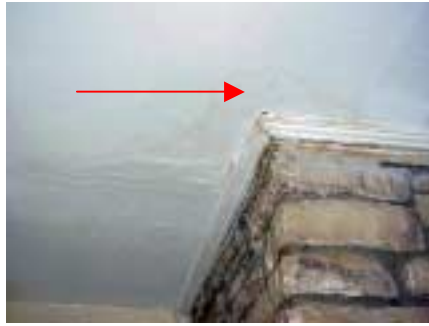
water penetration around chimney

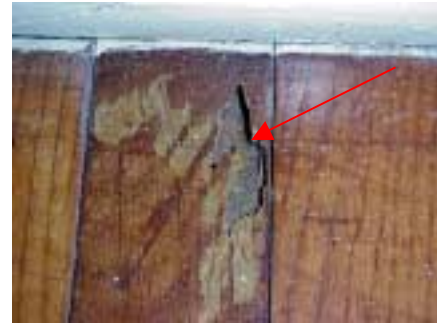
Subterranean Termite damage at floor

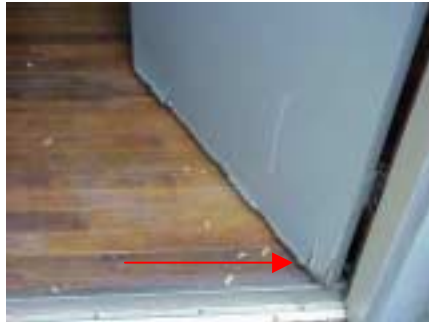
damage are rear exterior door

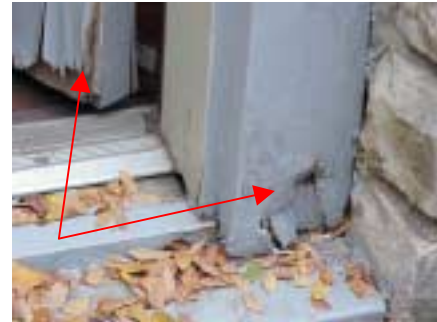
wood rot at rear exterior door / trim

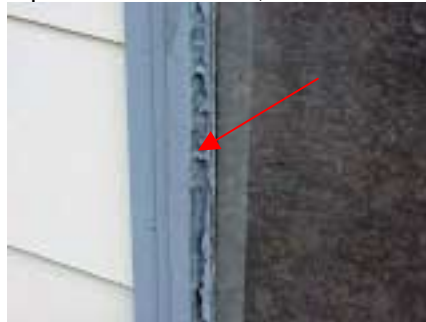
Several of the cranks that open the windows are not functioning. (approx. 8)  
 Several windows are stuck and will not open. (approx. 4)  
 One window at the front of the home is broken.  
 The latch at one kitchen window is not attached to the frame.  
 Many of the screens are missing at the windows. (approx. 13)  
 One screen frame is damaged.  
 Glazing compound is damaged at the exterior of one of the rear windows.

damaged glazing compound

I recommend that you consult with a reputable window company for evaluation and repair of the windows, as needed.

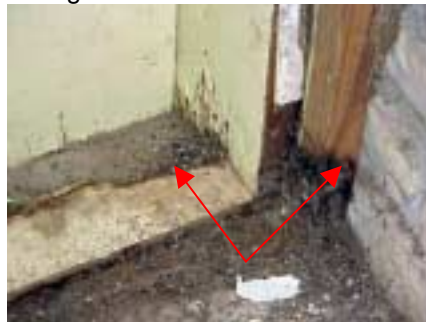
Wood rot was observed at the wood storage bin near the fireplace. Because the exterior door to this bin was locked, I was not able to probe the wood to check for evidence of Termites. (TPCL # 11736) A snake's skin was found in the wood storage bin.

wood rot in wood storage bin

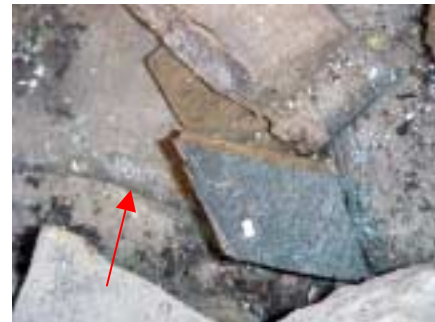
snake skin in wood storage bin

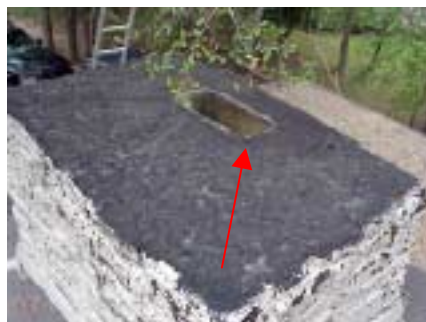
Creosote buildup and cracked flue tiles were observed at the fireplace chimney. There is no spark arrestor or rain cap at the chimney. Evidence of previous repairs was observed at the chimney. The exterior masonry at the chimney has been coated with tar. It is likely that this has been done in an attempt to compensate for damage at the top portion of the chimney. (temporary repair)

heavy tar coating at chimney / missing spark arrestor and rain cap

Minor sealing is needed near and around the lintel at the front face of the firebox. I recommend that you have the unit further evaluated and serviced/repared by a reputable chimney sweep prior to use.

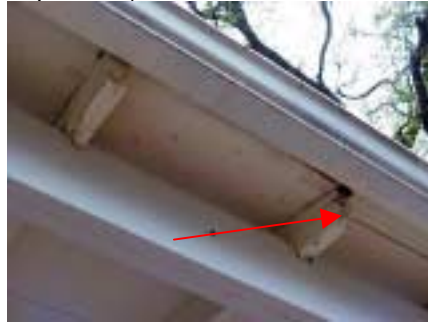
Evidence of wood rot was observed at most of the support posts at the carport and front porch. One post at the steps is not even attached to the base of the post. Wood rot was observed at the roof supports and decking of the carport in several locations.

The roof support system above the carport has failed and is in need of repair.

wood rot at carport deck and joists

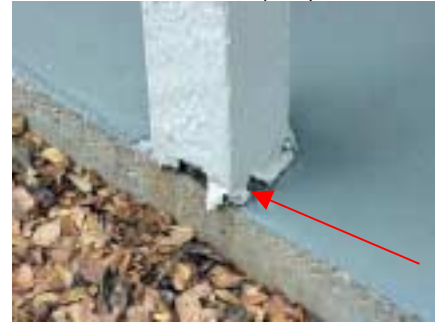
wood rot at carport post

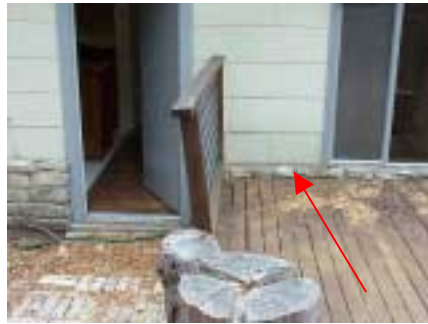
The rear deck is detached and excluded from the inspection. (per TREC standards of practice) I did notice that the rails at the deck are loose. (FYI)

loose rail are rear deck

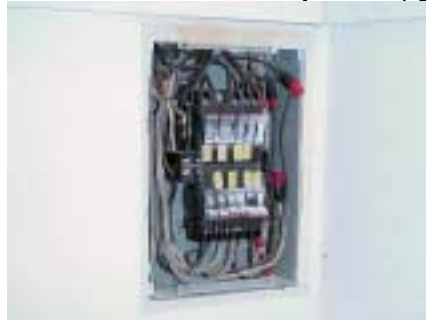
The panel box is located in the rear bedroom closet. This is no longer considered to be an appropriate location for a panel. Improper workspace and fire safety concerns are involved. At a minimum, I recommend that you do not store items in front of the panel box that would prevent access in the event of an emergency or that are flammable.

panel box in closet

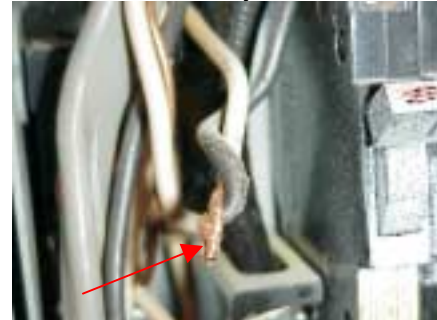
copper wire found with wire nut removed

White and black wires are spliced together in the panel box. Not only is this against electrical practices, the panel enclosure should not be used as a junction box. I removed one of the wire nuts to see if aluminum wiring was present and had been pig-tailed to copper. Copper wiring was found at both ends of the circuit. Ground Fault Circuit Interrupter (GFCI) protection is missing at all applicable circuits of the home.

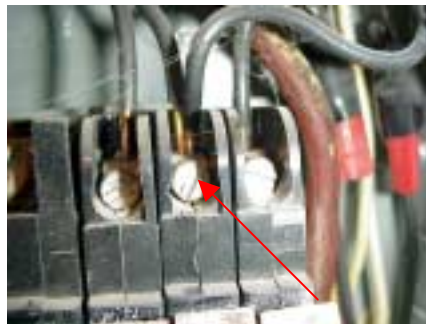
One double tapped 20-amp breaker was found in the panel. This breaker is not listed for use with more then one wire.

double tapped breaker

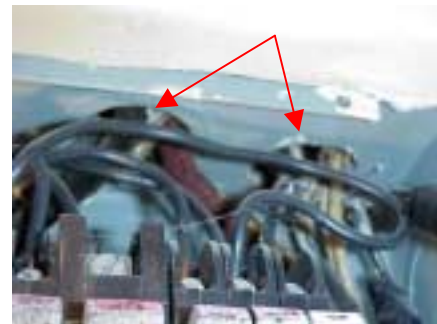
Bushing protection is missing from the knockouts at the interior of the panel box.

missing bushing protection

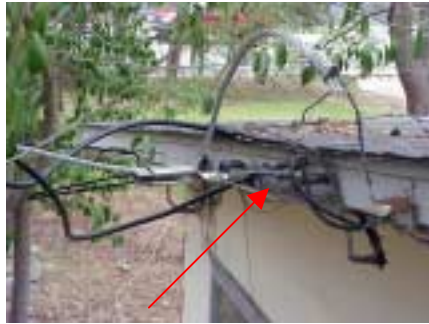
The service attachment at the right side of the home is inadequate.

inadequate service attachment

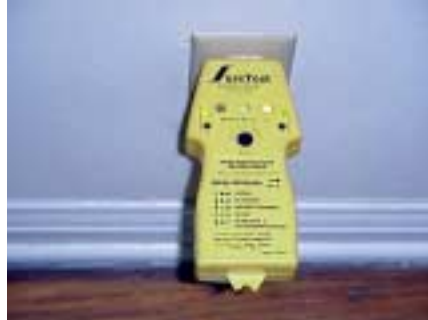
Of the four 3-pronged outlets found in the home, the only ones that are grounded were found in the bathroom and the rear wall of the living room. The 3-pronged outlets at the rear wall of the rear bedroom and the washing machine are not grounded.

grounded outlet in living room

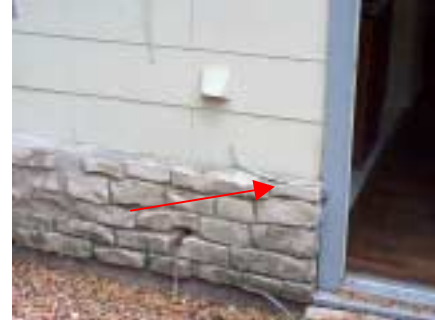
Conduit is missing at wiring in several locations around the home.

rear exterior wires missing conduit

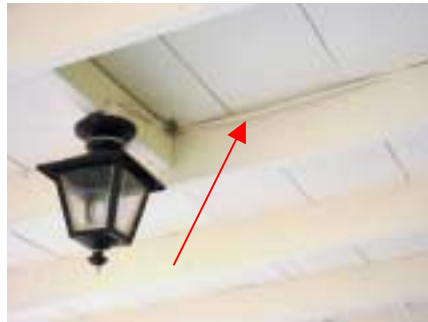
missing conduit at carport light

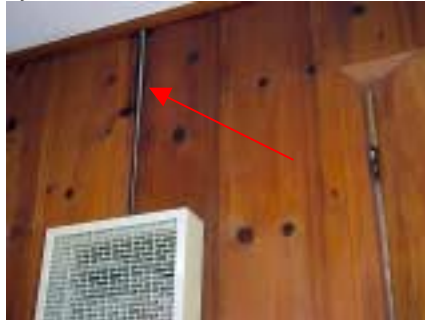
It is my opinion that these old units are a fire hazard. I recommend that you do not use it. You should consult with a licensed HVAC professional for information regarding additional heating and cooling alternatives, such as a central HVAC system.

evidence of overheating at panels above furnace

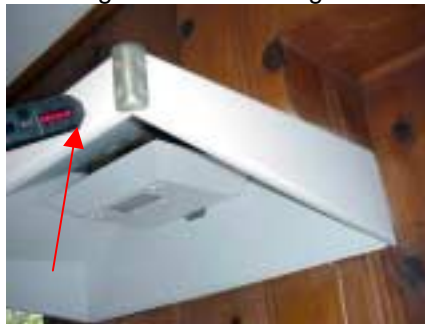
**C. Range Hood**  
Comments:  
The range hood in the kitchen is not grounded.  
The range hood fan and light in the kitchen are not functioning.

range hood not grounded
