Home Inspection Report

PROPERTY INSPECTION REPORT

Concerning: 123 Your Street Your Town, TX 12345
(Address or Other Identification of Inspected Property)

By: Brad Brusenhan / TREC # 4176 00/00/0000
(Name and License Number of Inspector) (Date)

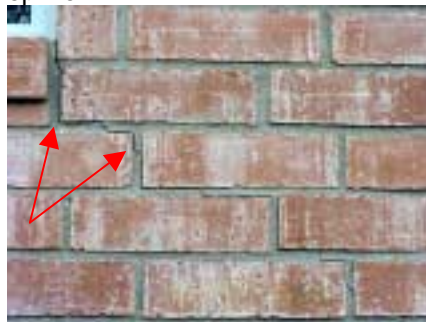
Brick and mortar separation was observed at the left side of the home near the rear left corner. (approximately 1/16th of an inch) It is my experience that a crack of this nature is uncommon for a home that has just finished construction. It is expected that some degree of settling will take place within the first 18 months after construction. I highly recommend that you monitor this separation closely. I have no way of predicting what will happen with the separation in the future. If it continues to get worse, an independent structural engineer should be contacted for further evaluation and recommendations as to how to stabilize the foundation. I recommend that you only hire an engineer that is willing to take elevations as part of his or her service.

separation at left exterior (monitor)

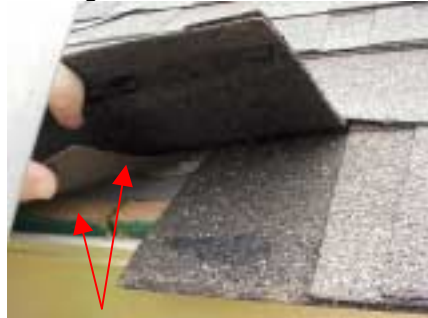
The lower tabs of the shingles at the starter course were not cut off of the shingles prior to installation, as the manufacture recommends. This prevents the starter course from sealing to the lowest edge of the roof, as it is intended to do. This installation error is found on a regular basis.

The underlayment at the roof has been cut back short of the exterior edge of the 1x2 trim at the fascia. This installation error is found on a regular basis.

starter course wrong and felt cut short

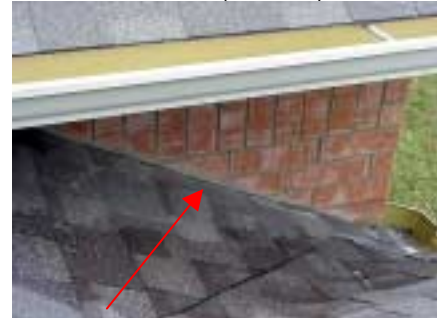
A non-conventional method of flashing has been used at the locations where sloped sections of the roof meet vertical sections of brick veneer. The brick veneer is currently being used as counter flashing. This method of flashing allows moisture to be wicked through the porous brick and mortar into the wall void behind the brick.

Due to the nature of the flashing it is not possible for me to see that it has been properly installed on the backside of the brick. There are currently no weep holes installed at the locations where the flashings exit the veneer at the front of the home. These weep holes are important to allow any moisture that ends up in the wall void to escape.

non-conventional method of flashing

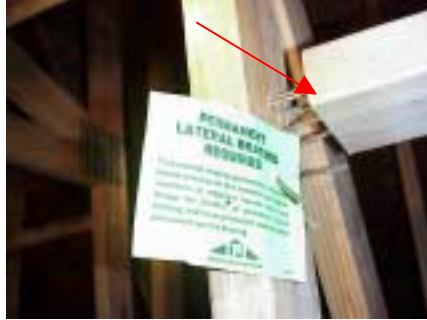
Comments:
 One horizontal truss brace is not properly installed in the attic. It is located at the left side of the walkway to the HVAC equipment.

brace not properly installed

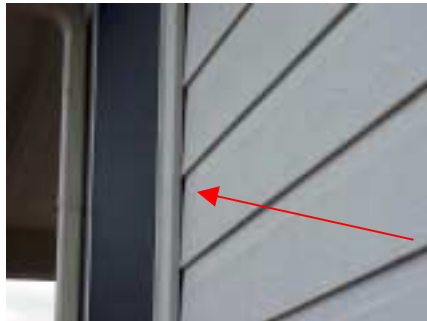
seal gaps at exterior

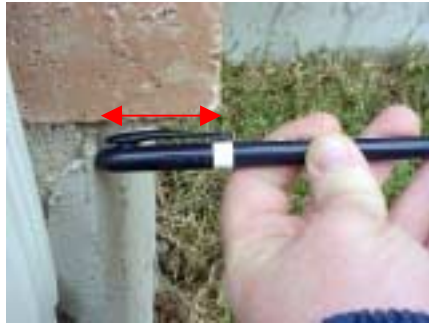
excessive overhang at right side

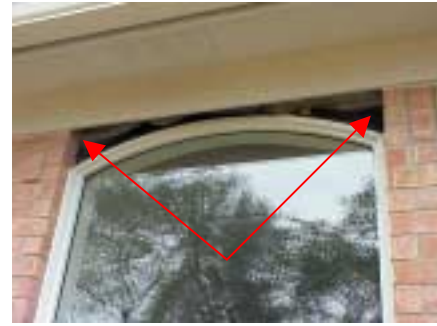
brick veneer missing above window

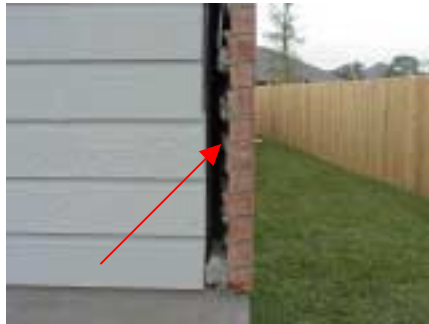
rear left corner not finished out

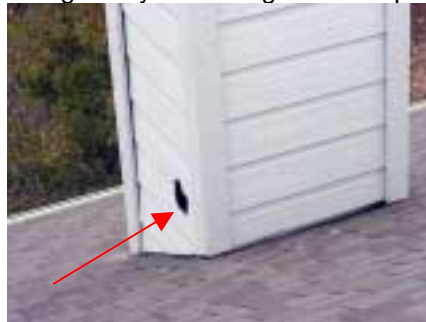
The combustion air damper/vent cap is not currently installed at the chimney. It will be important to insure that the vent is actually hooked up when the cap is installed. The gas key is missing at the fireplace.

combustion air cap missing at chimney

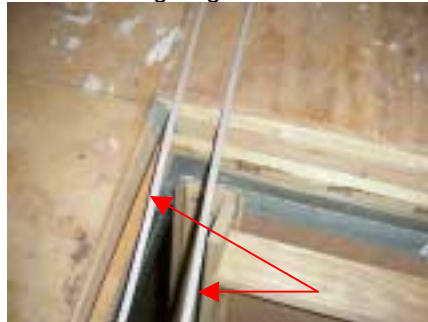
The plastic protection card is missing at the timer at the rear exterior of the home. Electrical wiring within 6 feet of the attic access in the garage is not properly secured.

wires not properly secured

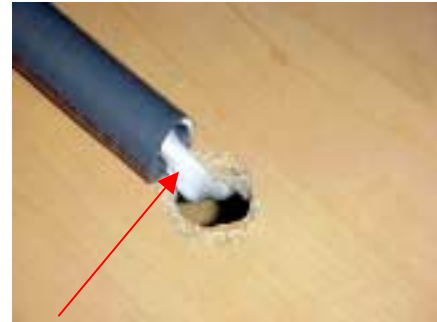
The conduit is not properly installed at the circuit below the kitchen island. Exposed wiring was found at both ends of the conduit.

conduit not properly installed

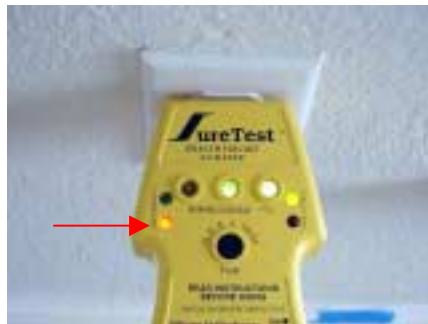
Greater than a 5% voltage drop was found at more than one circuit in the home.

While somewhat common, this situation could potentially damage sensitive electronics in the home.

excessive voltage drop

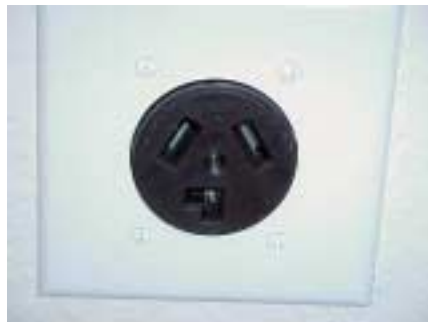
The dryer circuit is currently wired to a 3-prong receptacle. The circuit should be wired with a four-prong service to a receptacle containing prongs for 2 hot, one neutral and one ground wire. This method of wiring a dryer circuit has been in practice for several years now.

3-prong dryer plug

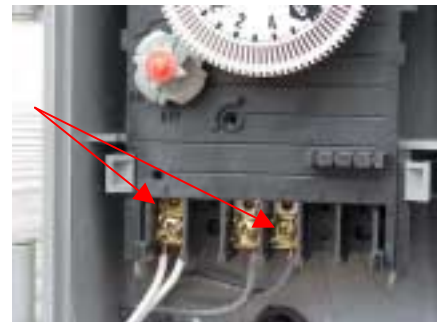
missing plastic protection card at timer

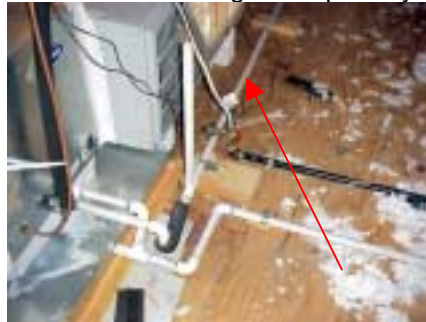
Insulation is missing at the primary condensation drain line in the attic.

missing insulation at primary condensation drain

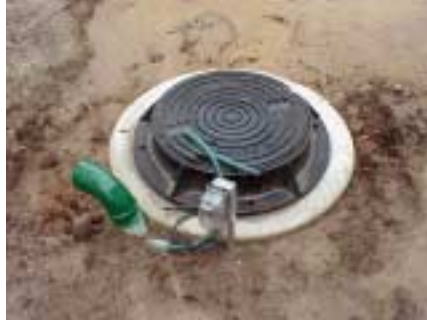
The rainwater collection system was not inspected. I recommend that you contact the installer or another professional that is familiar with these systems for maintenance advice and verification of proper installation. (FYI)

rain water collection system?

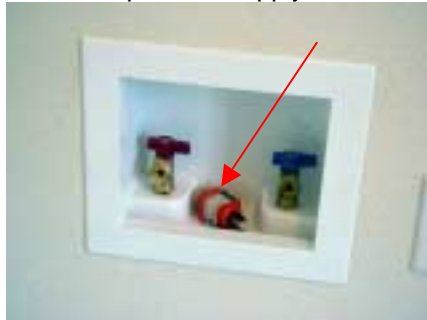
The drain cap has not been removed from the washing machine drain. I was not able to inspect the supply or waste lines at this location.

remove drain cap at washer
