Home Inspection Report

PROPERTY INSPECTION REPORT

Concerning: 123 Any Street Your Town, TX 12345
(Address or Other Identification of Inspected Property)

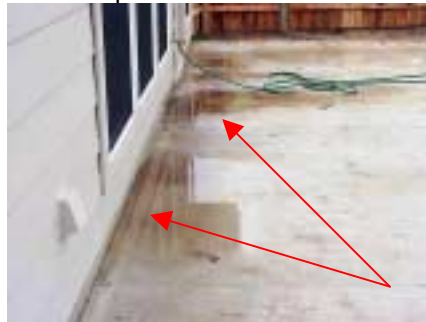
Water was observed ponding at the patio near the rear of the foundation at the time of the inspection.

improper drainage at rear patio

Proper drainage is *critical* to the future performance of the foundation. If for any reason water is found standing near the foundation for an extended time, (more then 24 hours) drainage corrections will be necessary.

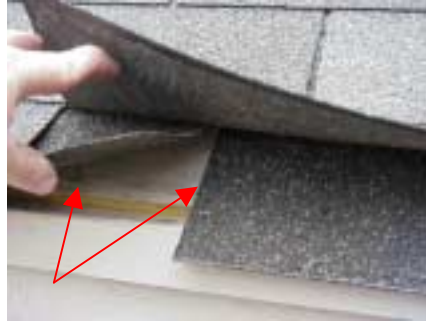
The lower tabs of the shingles at the starter course were not cut off of the shingles prior to installation, as the manufacture recommends. This prevents the starter course from sealing to the lowest edge of the roof, as it is intended to do. This installation error is found on a regular basis.

The underlayment at the roof has been cut back short of the exterior edge of the 1x2 trim at the fascia. This installation error is found on a regular basis.

starter course not properly installed
felt cut short at drip edge

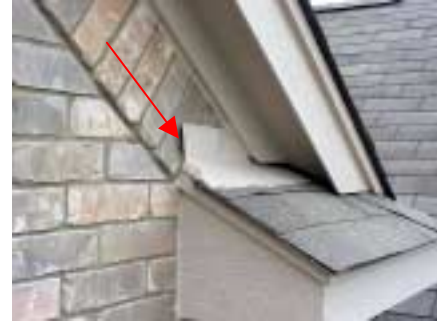
Counter flashing is missing at the sides of the gable above the front entry.

missing counter flashing above front entry

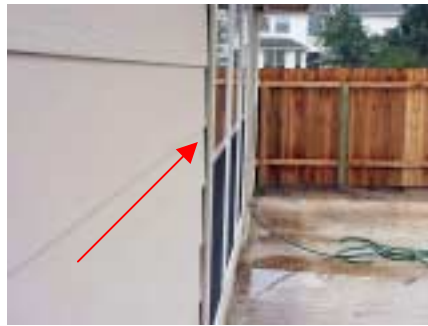
The areas where the siding is run behind trim at the exterior should be caulked. This will help prevent wood rot at the siding and trim in the future.

seal all gaps at siding and trim as recommended by manufacturer

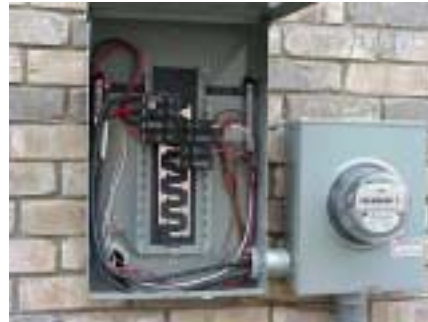
main panel at left exterior

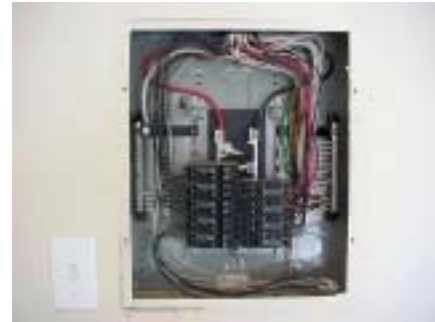
sub-panel in garage

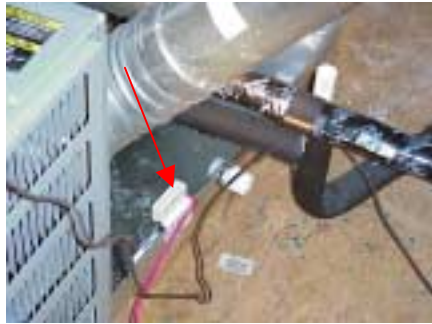
Due to exterior temperatures, the air conditioning equipment was not operated as part of the inspection. (below 60 degrees)
 There is a float switch installed at the drain pan below the evaporator coils in the attic. As all mechanical devices eventually do, this one may fail to work at some point in the future. For added protection against leakage and damage to the home, I recommend that you have the drain line from the pan below the unit extended to an appropriate area of the home's exterior. (FYI)

extend drain from pan to exterior

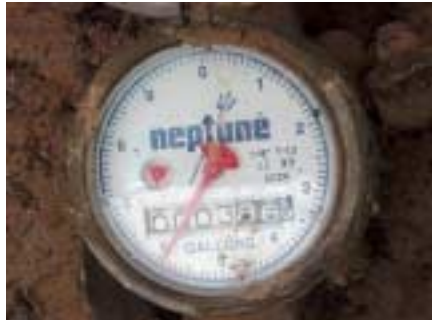
The tanks are loose at the toilet bowls.
The hot and cold water lines are not properly installed at the washing machine connections. The hot should always be on the left and the cold on the right. (water lines reversed in wall)
The water meter indicated that water was passing through the system while all faucets in the home were turned off. (possible leak at system) I recommend that you have a plumber trace the source of the leak and correct it, prior to closing.
The faucet is loose at the master bathtub.

meter indicates that there is a leak in the system

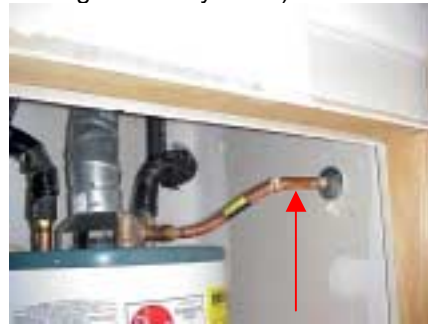
The temperature and pressure (T&P) drain line at the water heater does not gravity drain. (correction by plumber is recommended / potential cross connection or damage to safety valve)

T&P drain line does not gravity drain
